**SUPPLEMENTAL WATERSHED PLAN NO. 1
and Environmental Assessment
for the Rehabilitation of
Floodwater Retarding Structure No. 2
of the
Upper Cibolo Creek Watershed
Kendall County, Texas**

Prepared By:
U.S. Department of Agriculture - Natural Resources Conservation Service

February 2023

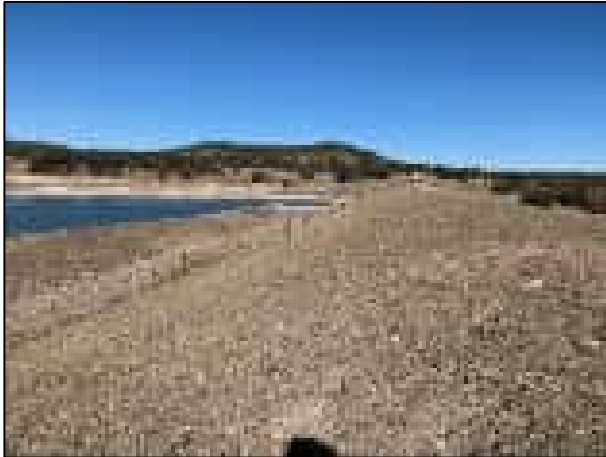
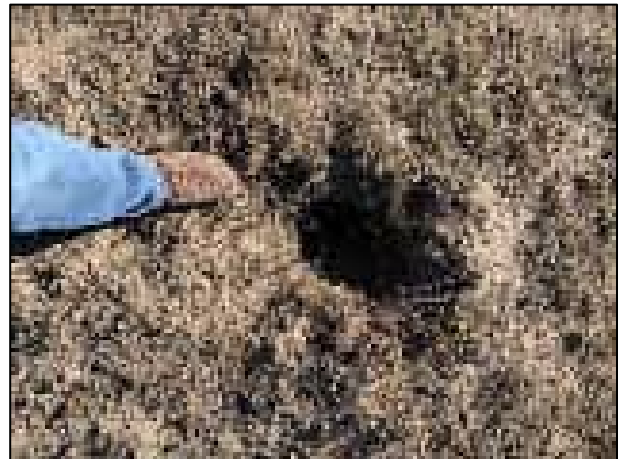
Figure 3-3. FRS No. 2 Embankment Condition

as-builts. There were rodent holes observed on the dam crest and on both the upstream and downstream slopes. The upstream and downstream embankments were found to be in adequate condition, during the 2020 inspection. Small trees were observed growing on the downstream embankment. The riprap that is shown on the upstream embankment in the as-builts (at the berm) was not present during the site visit. During the 2020 inspection, it was observed that there is a road that travels up the right side of the embankment and over the dam crest. The elevation where the road crosses the dam crest is lower than the top of dam elevation. There was a small seep of clear water observed at the toe of the downstream slope on the bench above the plunge pool. Embankment photos are provided in **Figure 3-3**.

Upstream embankment and crown of dam (2020)

Downstream seep (2020)

Rodent hole (2020)

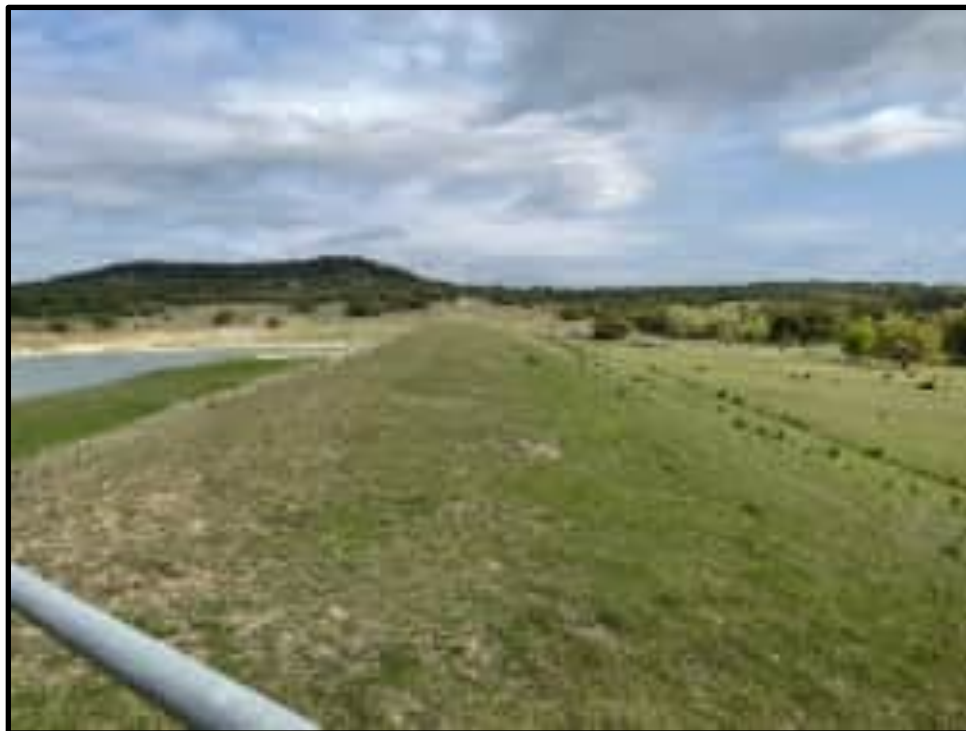
Figure 5. Overview of FRS No. 2 dam, facing north

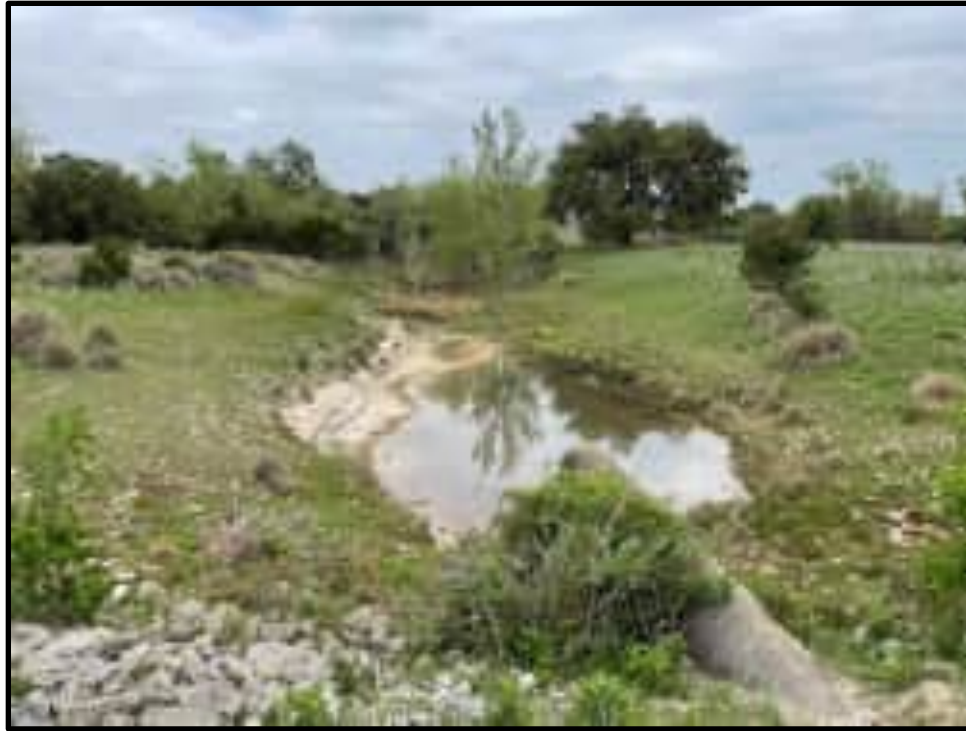
Figure 10. View of FRS No. 2 outlet pipe and plunge basin, facing east

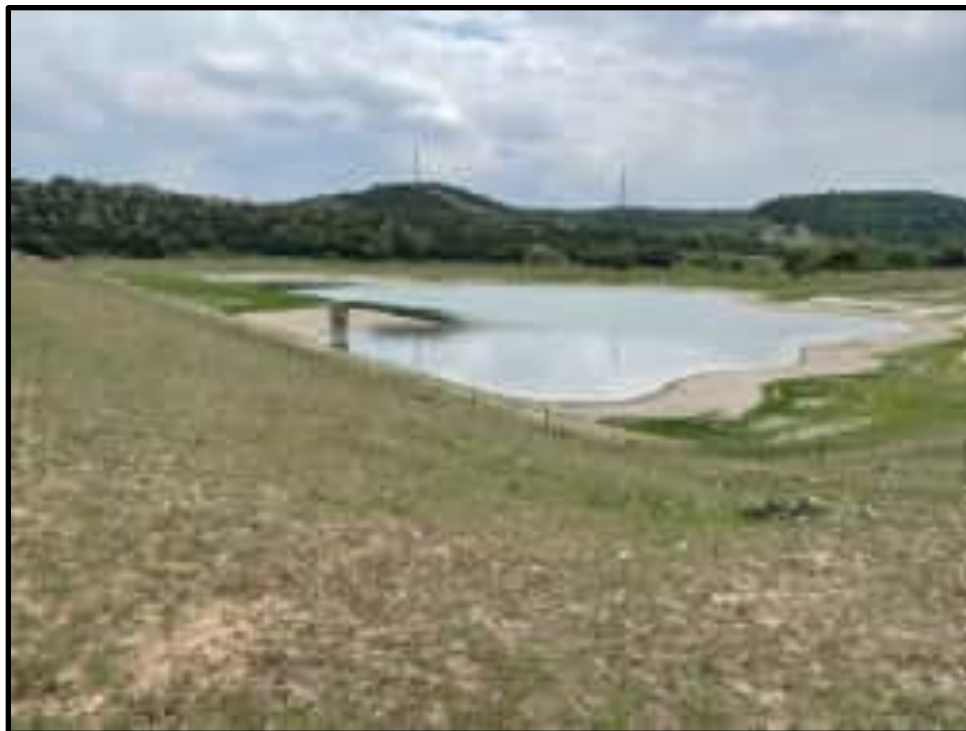
Figure 11. View of intake structure and impound area west of FRS No. dam, facing southwest

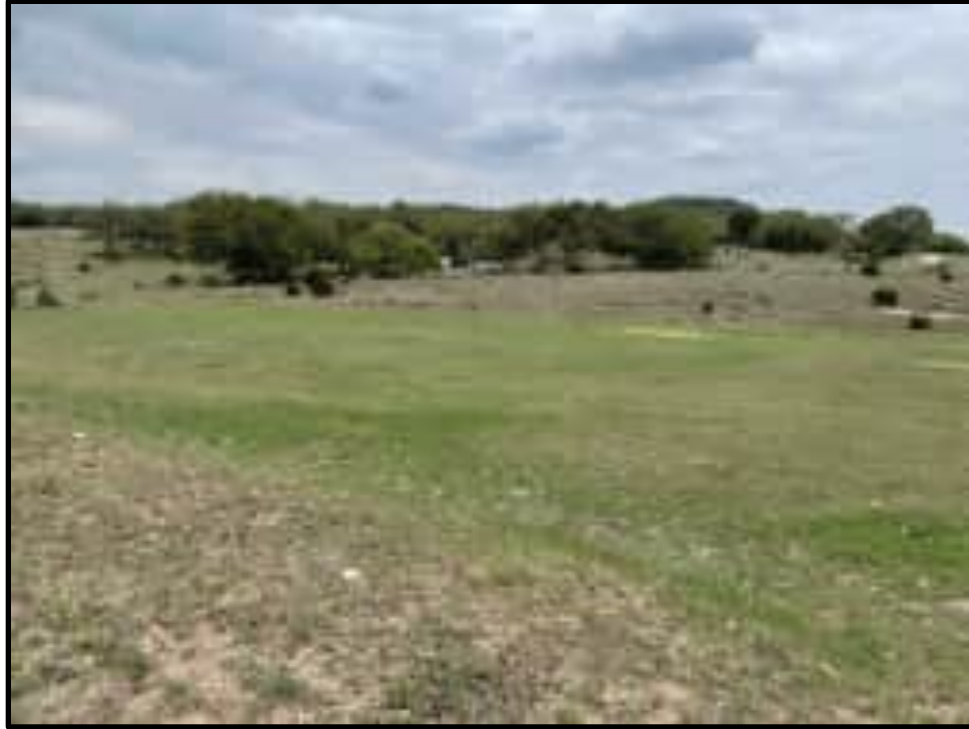
Figure 12. View of FRS No. 2 auxiliary spillway, facing north

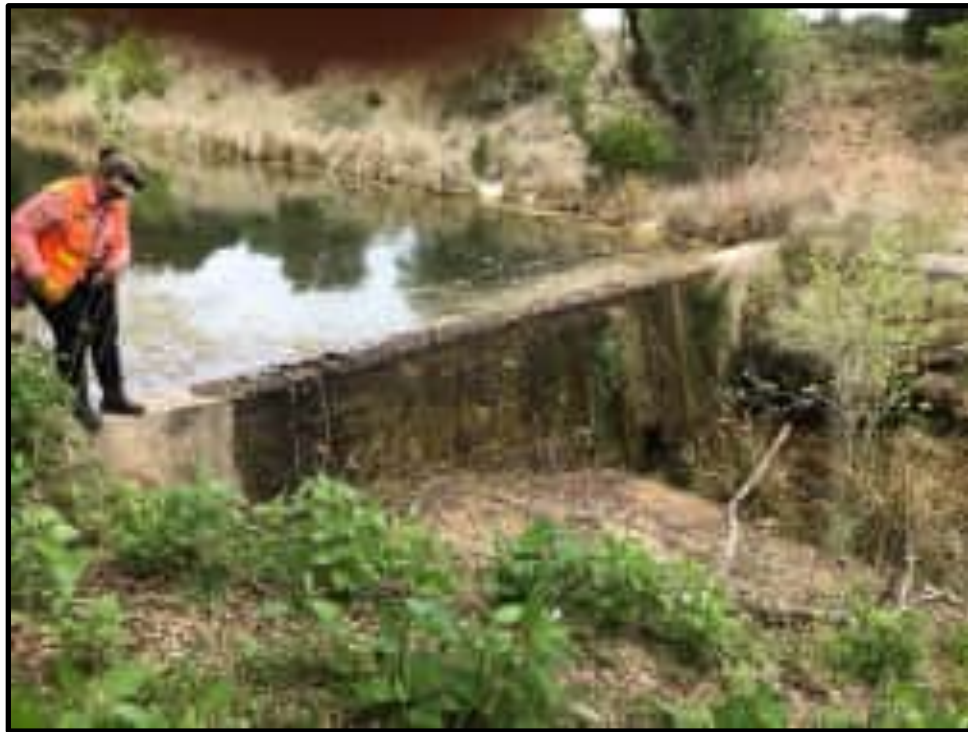
Figure 36. View of Resource 001 concrete dam, facing northeast

The dam is visible in aerial photography from 1955 and 1963. Based on design, materials, and workmanship, as well as photographic evidence, the resource is greater than 45 years of age and the date of construction is estimated to be around 1950. Based on this information, Resource 001 meets the age requirement for NRHP eligibility consideration and was evaluated for NRHP eligibility based on criteria presented in 36 CFR Part 63 [a–d]. Resource 001 does not appear to have been altered, and the surrounding landscape has remained undeveloped. Therefore, the resource has retained integrity of location, design, materials, workmanship, setting, feeling, and association. Although the resource retains integrity, its association with flood control development or agriculture in the Cibolo Creek Watershed is not sufficient for NRHP-listing as there are other examples of these types of resources in Kendall County, with similar historical context. The resource is also not associated with a pattern of development in Kendall County. Resource 001 fails to illustrate any known association with significant historical events or a significant pattern of development in Kendall County, and does not qualify for NRHP eligibility under Criterion A. The resource is also not associated with significant persons in history and lacks engineering design merit to qualify for NRHP eligibility under Criteria B or C. Finally, the resource is not likely to yield information important to history or prehistory, and does not qualify for NRHP eligibility under Criterion D. Therefore, Resource 001 is recommended not eligible for listing in the NRHP. Furthermore, Resources 001 does not merit SAL designation.

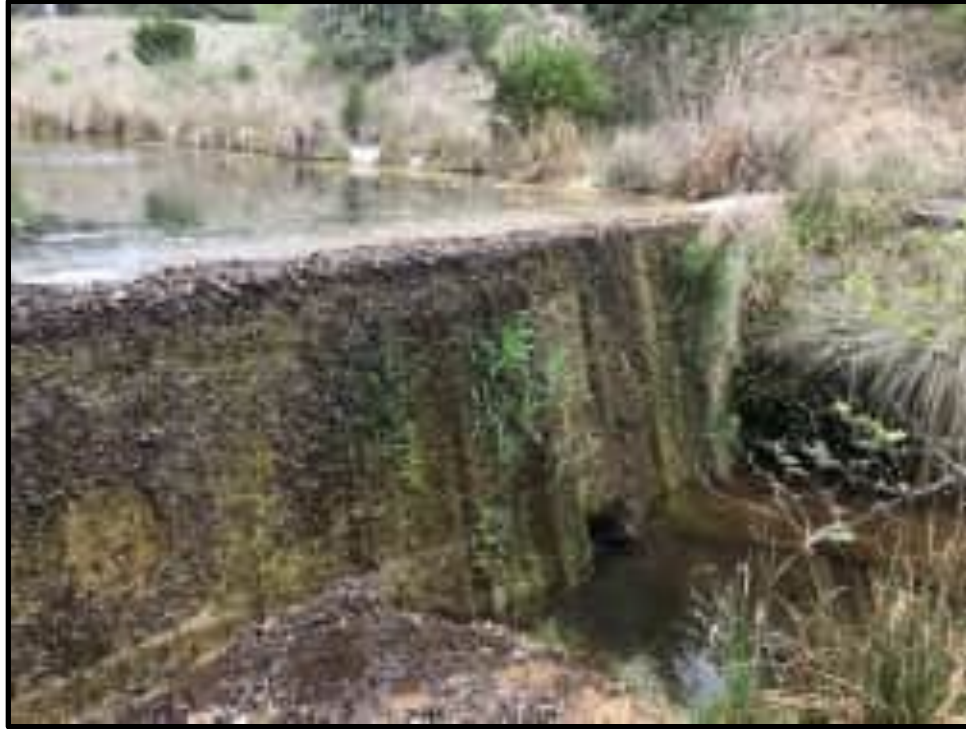
Figure 37. View of Resource 001 showing concrete outlet opening in base of southeast side of dam, looking northeast
